# BLACK ROCK TURNPIKE SAFETY STUDY

# FINAL EXISTING AND FUTURE CONDITIONS TECHNICAL MEMORANDUM

FEBRUARY 2018

## Existing & Future Conditions Technical Memorandum

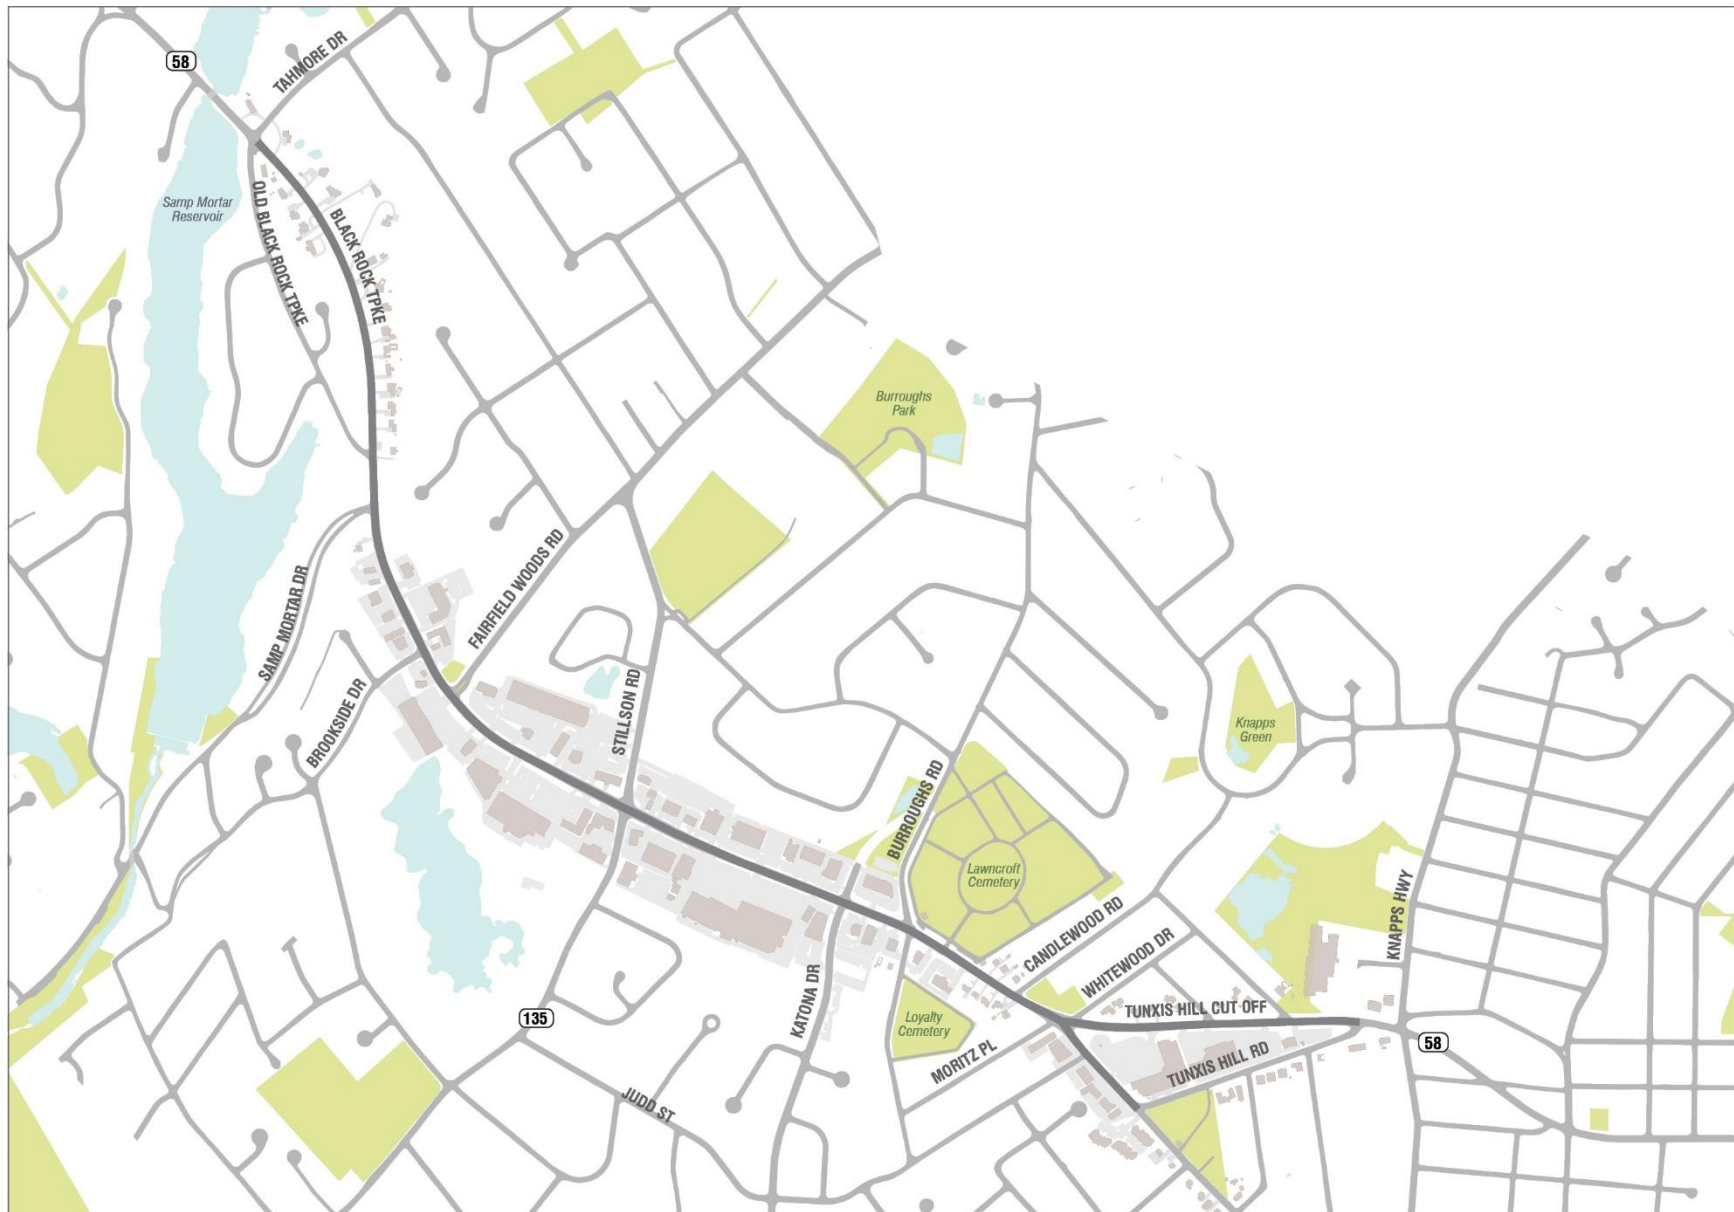
**Figure 2-3: Black Rock Turnpike Study Base Map** (Source: MetroCOG Geodatabase June 2017)

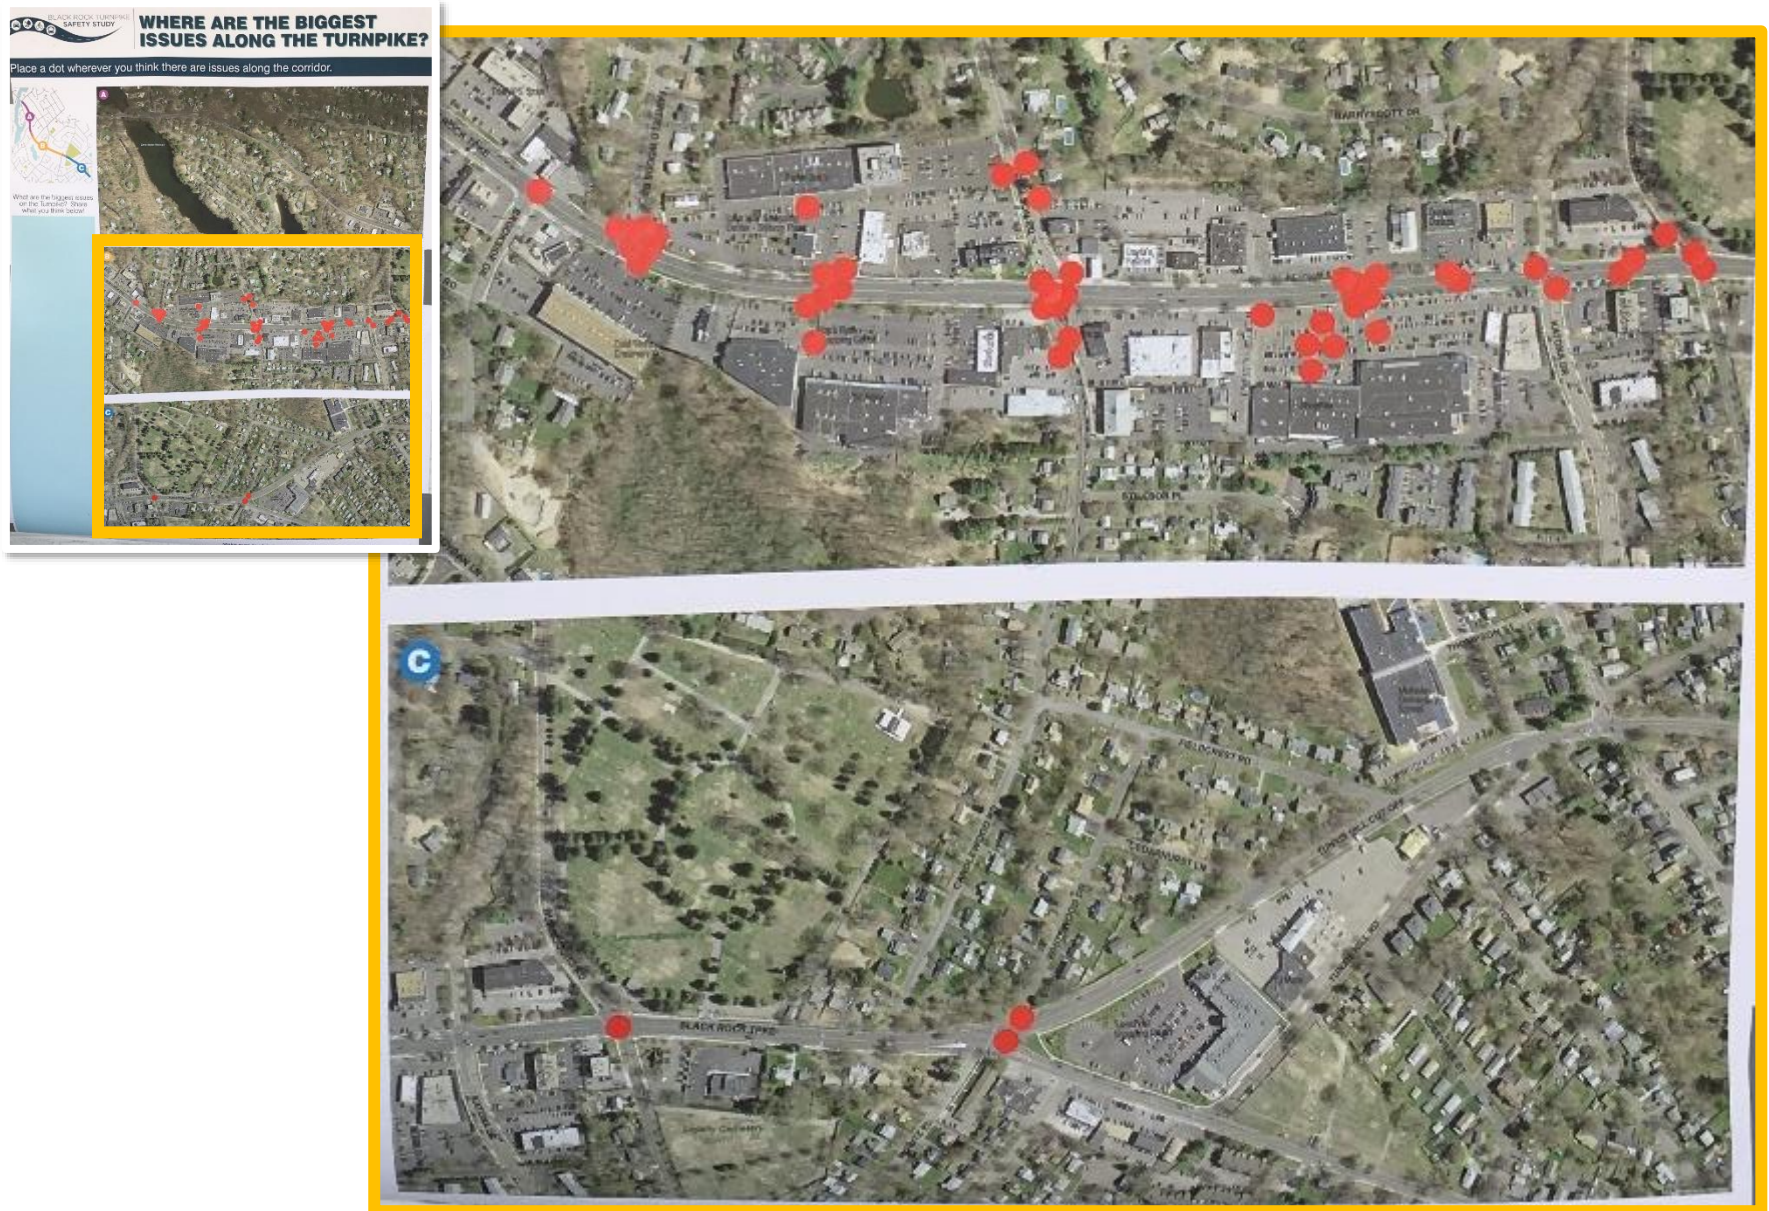
**Figure 2-10: Map of Public Input during Pop-Up Outreach Event on June 3<sup>rd</sup>, 2017: Issue Areas along Black Rock Turnpike**

A second poster displayed a more detailed map of the study area along with the question prompt, “Where are the biggest issues along the Black Rock Turnpike?” Attendees were provided a set of sticker dots that they used to place wherever they thought issues exist. Staff was on hand to talk with participants about the areas they were marking and why. The resulting map, shown in Figure 2-10 on the following page, clearly illustrates that the area between Brookside Drive and Burroughs Road is in need of improvements. All the intersections were noted as problematic in some way as well as the driveway entrance to ShopRite. Many participants also described various issues within the parking lots off the Turnpike as well.

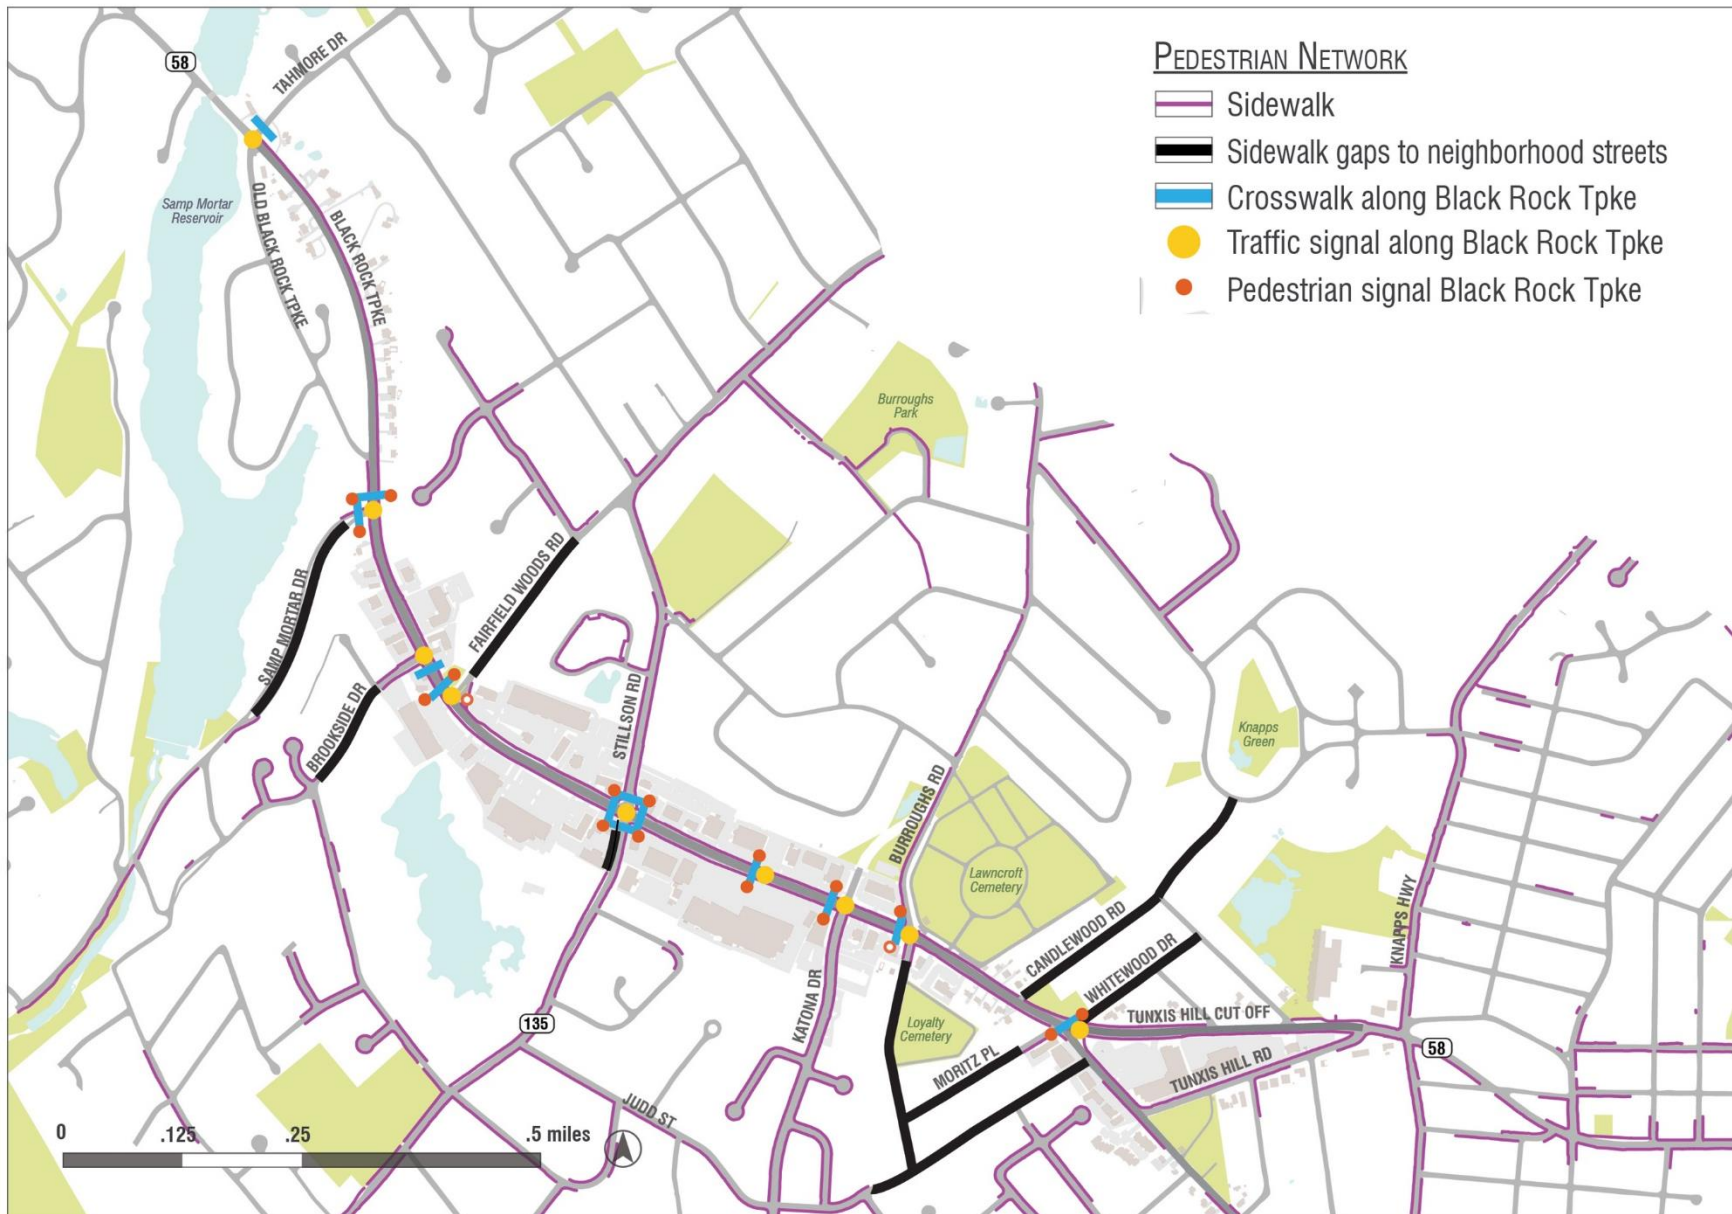
**Figure 3-21: Pedestrian Network** (Source: MetroCOG Geodatabase June 2017, Fitzgerald & Halliday Field Data June 2017)

While the sidewalk is continuous along the Black Rock Turnpike, the significant number of driveways cause breaks in the pedestrian

While these crosswalks do help to increase safety for everyone along the Turnpike, there are still issues. Fatal crashes involving pedestrians have occurred as recently as 2016 at or near the intersection with Katona Drive. These events are devastating for those involved, their families, and the whole community and this study will urgently seek improvements to prevent such events in the future.

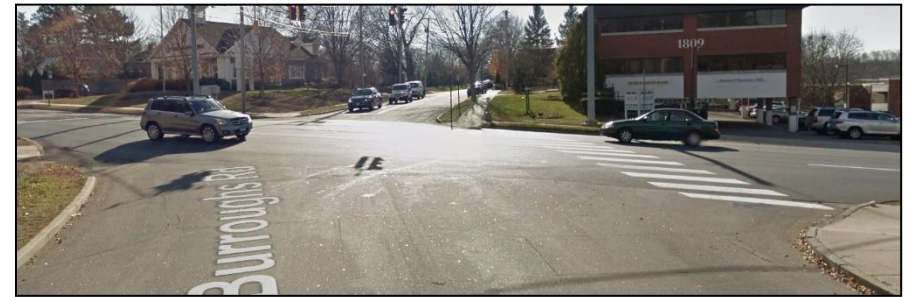
**Figure 3-35: View of Burroughs Road and Black Rock Turnpike Intersection** (Source: Google Street View, September 2017)

Road was struck by a tractor-trailer truck as it crossed the intersection. A view of this intersection, taken from Google Street View is shown in Figure 3-35.

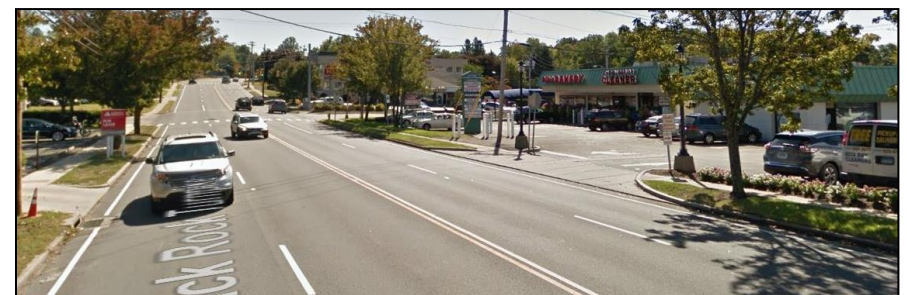
**Figure 3-36: View of Black Rock Turnpike, just east of Katona Drive** (Source: Google Street View, September 2017)

The third fatal crash occurred along Black Rock Turnpike, slightly east of the intersection with Katona Drive; just over 500 feet from the location of the other two fatal crashes. It happened on September 27, 2016 at 7:47pm. The crash occurred as a pedestrian was crossing Black Rock Turnpike between intersections, and was struck by a vehicle travelling eastbound on Black Rock Turnpike. A view of this area, from Google Street View, is provided in Figure 3-36.
